**Block 26-50 The Beeches, Queenswood Road
TYPE 2 SURVEY REPORT S10067.2**

Site | **Block 26-50 The Beeches
Queenswood Road
Wanstead
London
E11**

Date | February 2010

Introduction SURVEY REPORT S10067.2

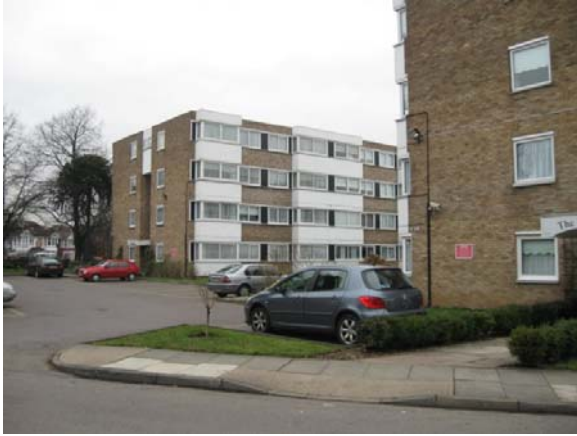
- **External** – Black AC infill panels were identified between external windows to Block 26-50 The Beeches.

External	60886 A	AC Panel	Chrysotile	1m ² each	Satisfactory condition	Sealed	4/12	Direct access	ASBESTOS PRESENT	
----------	---------	----------	------------	-------------------------	---------------------------	--------	------	---------------	---------------------	--

Photograph 5: AC infill panels between external windows.

Monitor condition of
material.
