Block 1-25 The Doves, Queenswood Road TYPE 2 SURVEY REPORT S10067.1

Site | **Block 1-25 The Doves
Queenswood Road
Wanstead
London
E11**

Date | **February 2010**

Introduction SURVEY REPORT S10067.1

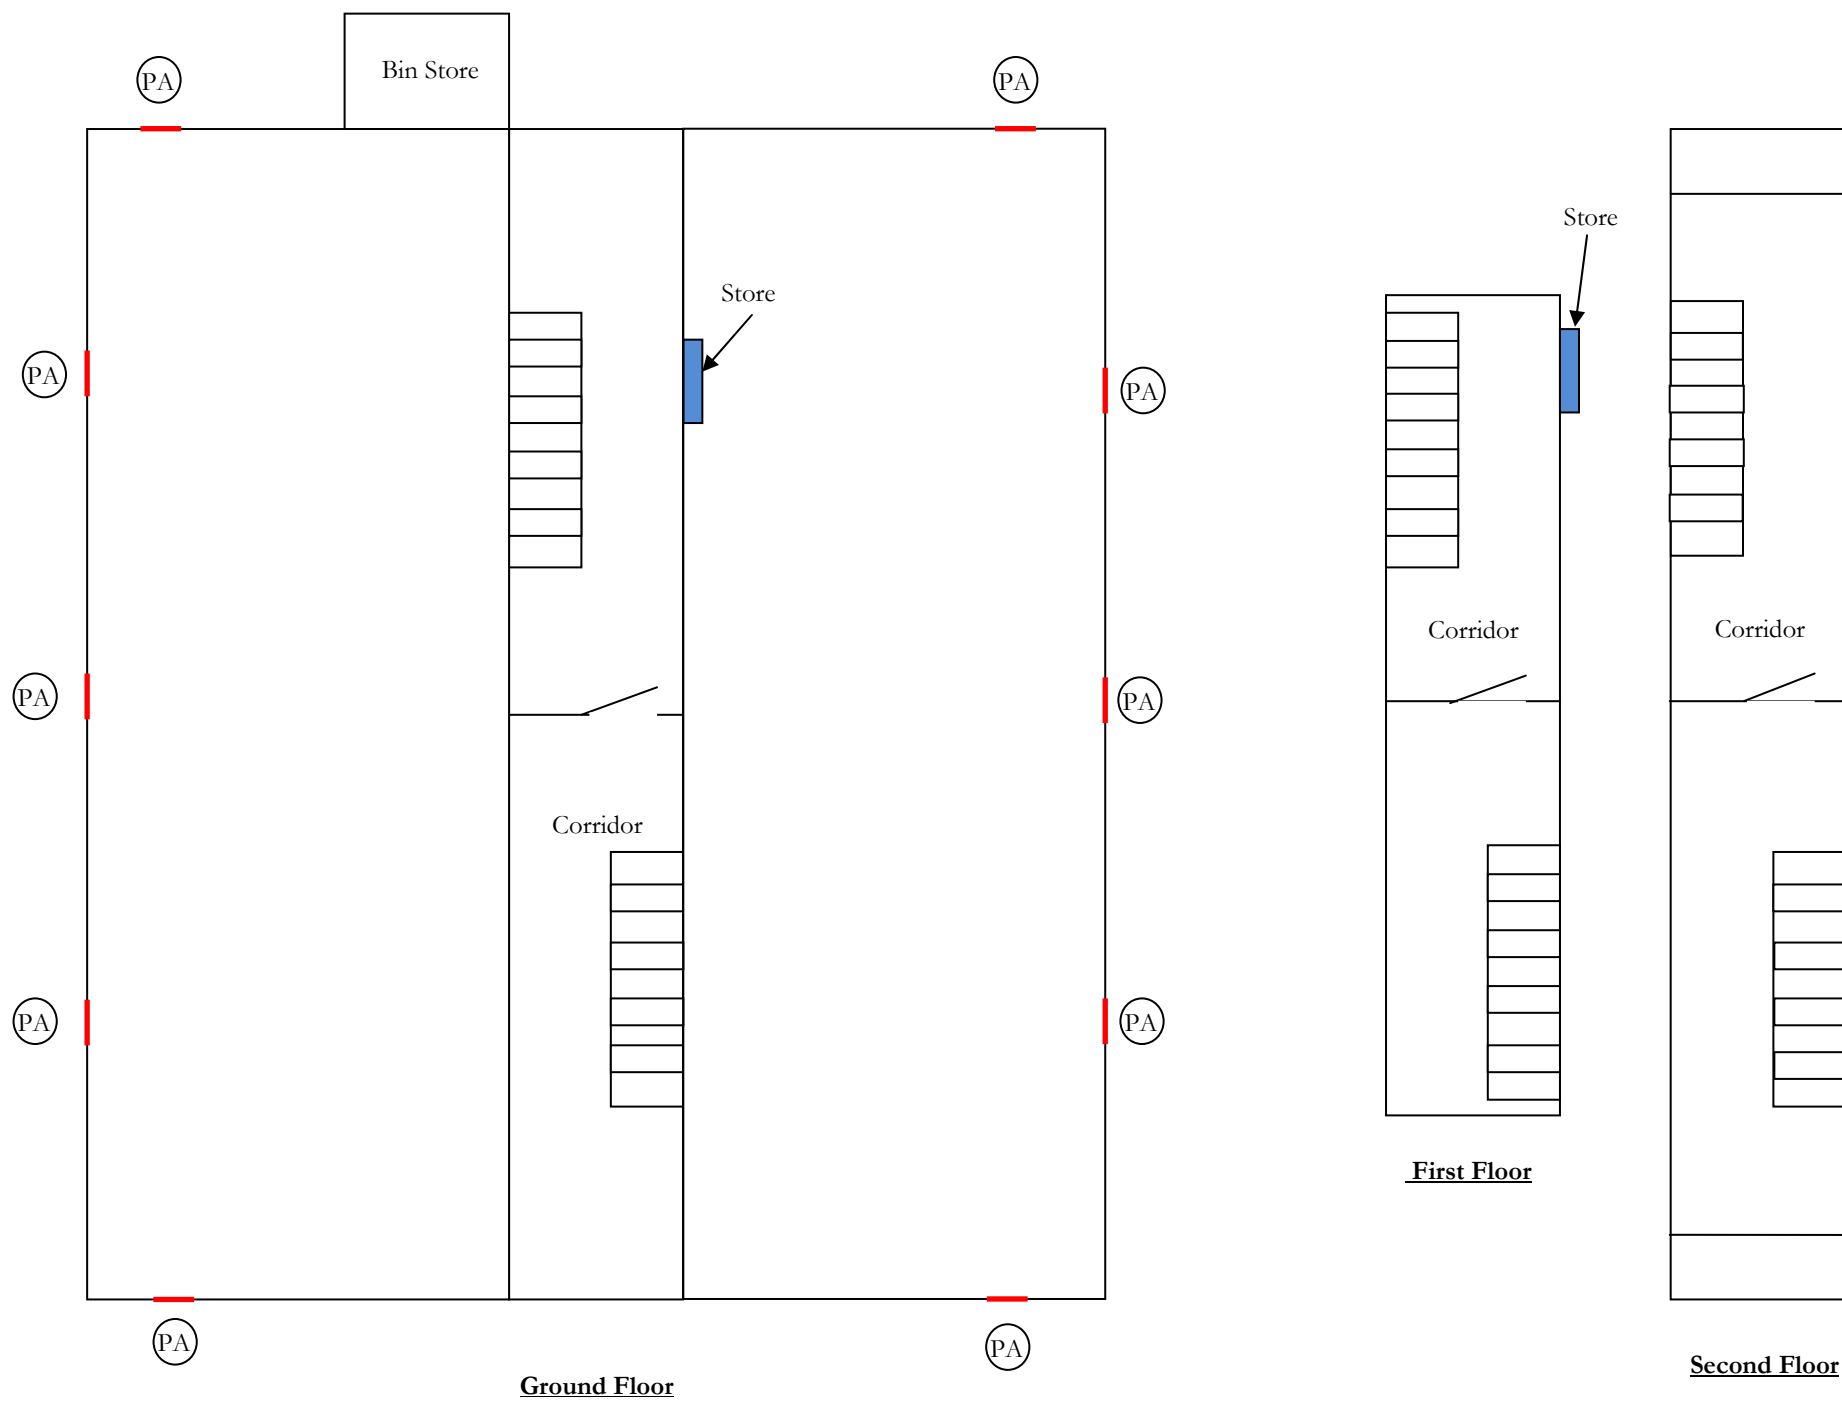
10067.1/001 Ground, First & Second Floors

Asbestos Materials Identified

No Access

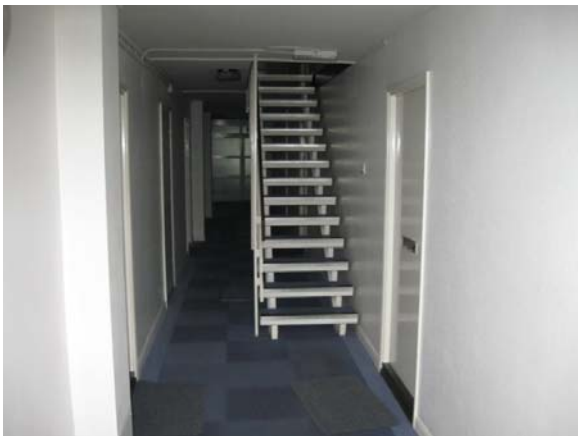
Photograph 1: Example of Ground Floor Corridor

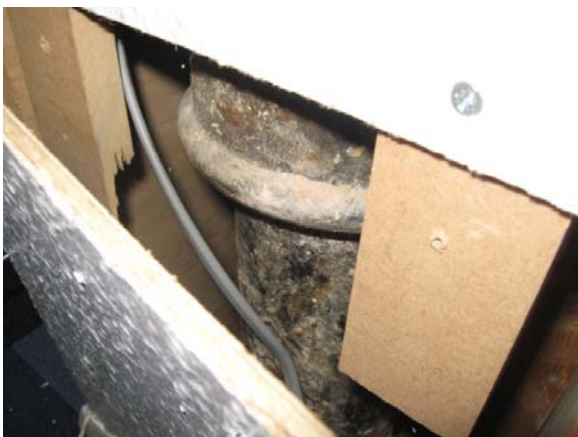
Photograph 3: Example of waste pipe riser identified within the Ground and First Floor Corridors
