**Block 142-158 The Elms, Queenswood Road  
TYPE 2 SURVEY REPORT S10067.6**

Site | **Block 142-158 The Elms  
Queenswood Road  
Wanstead  
London  
E11**

Date | February 2010

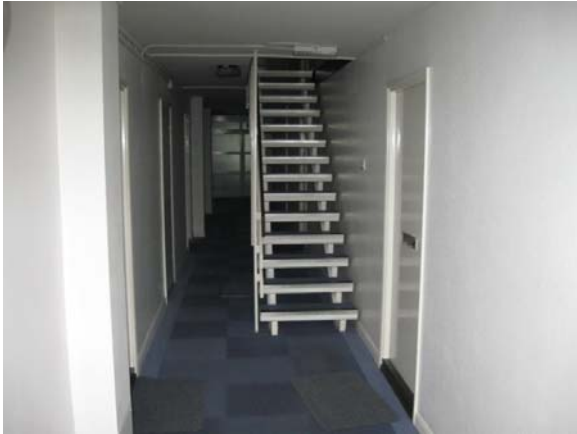
**Photograph 1:** Example of Ground Floor Corridor

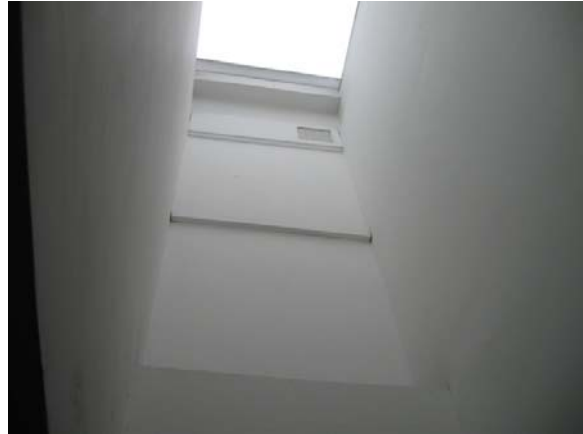
**Photograph 2:** No access was possible to the Skylight's present in the Corridor on the Second Floor

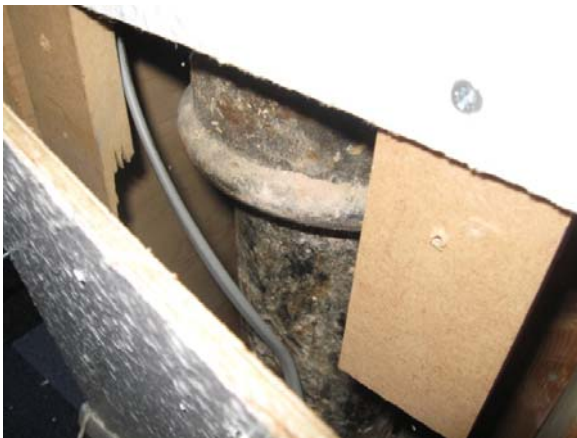
**Photograph 3:** Example of waste pipe riser identified within the Ground and First Floor Corridors

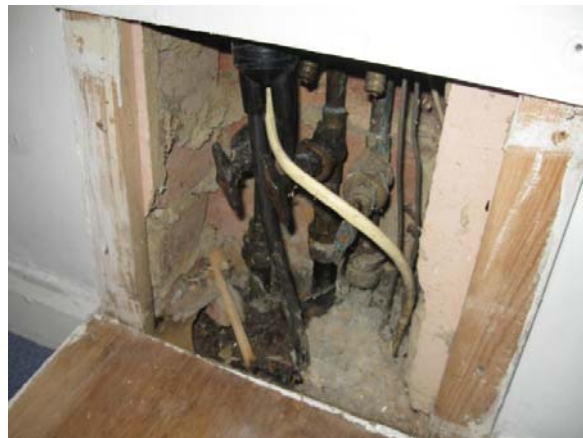
**Photograph 4:** Example of mains water pipe riser identified within the Ground and First Floor Corridors

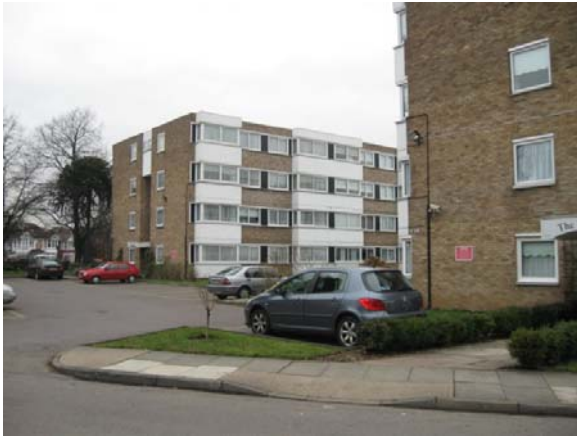
- **External** – Black AC infill panels were identified between external windows to Block 142-158 The Elms.

External	60900 A	AC Panel	Chrysotile	1m <sup>2</sup> each	Satisfactory condition	Sealed	4/12	Direct access	ASBESTOS PRESENT	
									Monitor condition of material.

**Photograph 5:** Black AC infill panels between external windows.
