**Block 109-141 The Firs, Queenswood Road
TYPE 2 SURVEY REPORT S10067.5**

Site | **Block 109-141 The Firs
Queenswood Road
Wanstead
London
E11**

Date | **February 2010**

Introduction SURVEY REPORT S10067.5

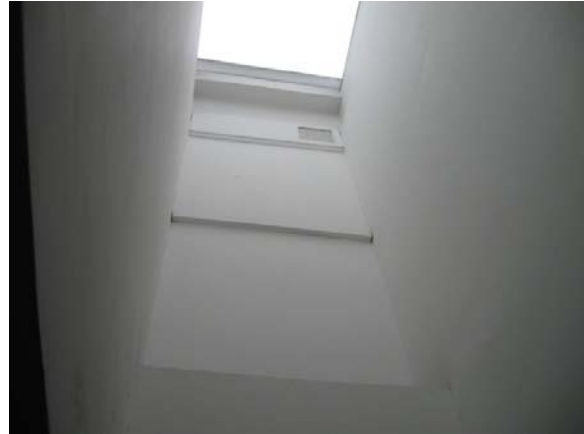
Photograph 2: No access was possible to the Skylight's present in the Corridor on the Second Floor

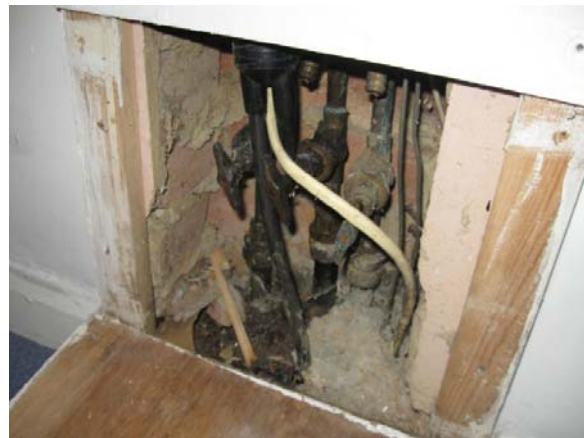
Photograph 4: Example of mains water pipe riser identified within the Ground and First Floor Corridors
