Block 84-108 The Cedars, Queenswood Road TYPE 2 SURVEY REPORT S10067.4

Site **Block 84-108 The Cedars
Queenswood Road
Wanstead
London
E11**

Date **February 2010**

Introduction SURVEY REPORT S10067.4

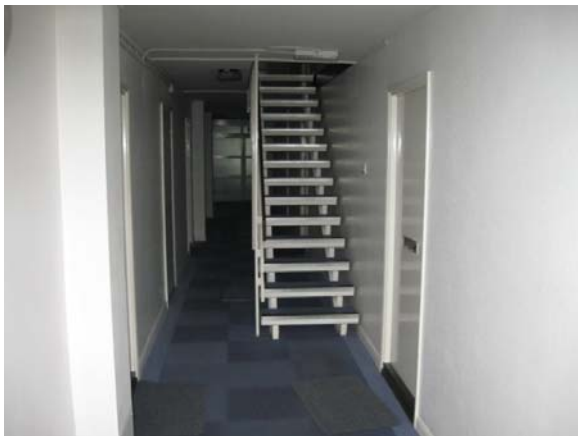
Photograph 1: Example of Ground Floor Corridor

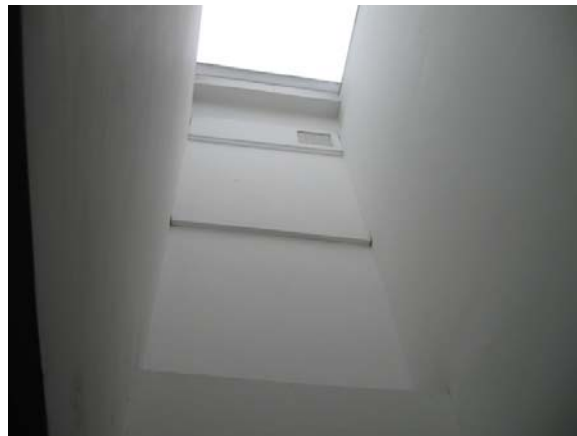
Photograph 2: No access was possible to the Skylight's present in the Corridor on the Second Floor

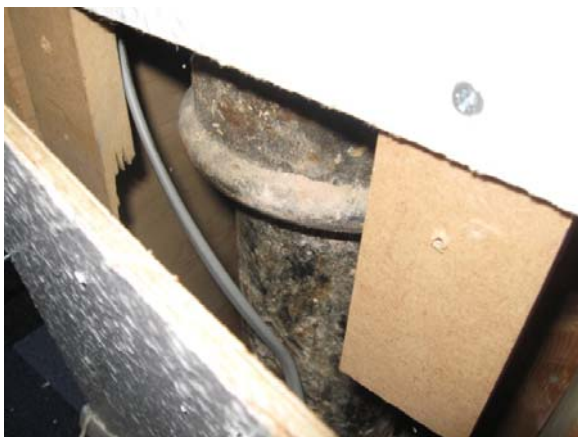
Photograph 3: Example of waste pipe riser identified within the Ground and First Floor Corridors

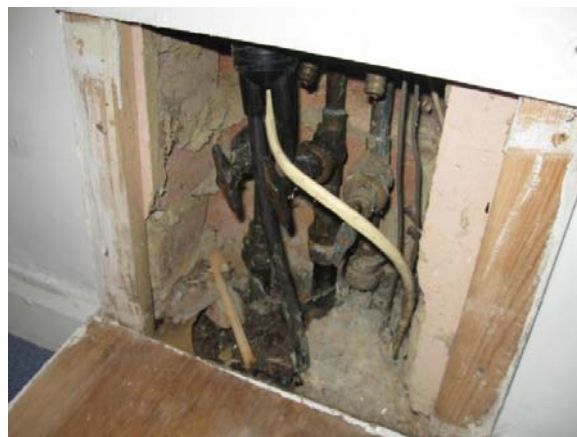
Photograph 4: Example of mains water pipe riser identified within the Ground and First Floor Corridors

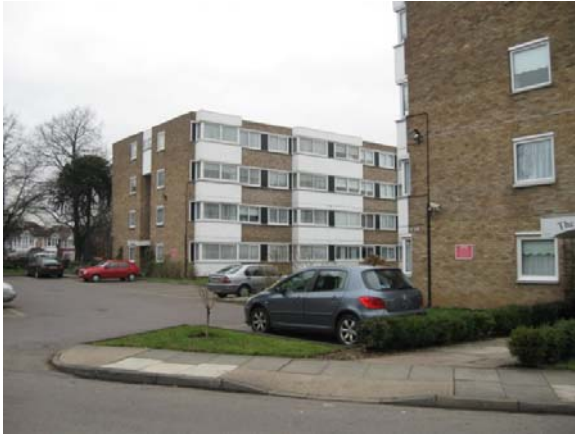
- **External** – Black AC infill panels were identified between external windows to Block 84-108 The Cedars.

| External | 60896 A | AC Panel | Chrysotile | 1m ² each | Satisfactory condition | Sealed | 4/12 | Direct access | ASBESTOS PRESENT | Monitor condition of material. |

Black Asbestos Cement (AC) infill panels between external windows.

Photograph 5: Black AC infill panels between external windows.
