**Block 142-158 The Elms, Queenswood Road  
TYPE 2 SURVEY REPORT S10067.6**

Site | **Block 142-158 The Elms  
Queenswood Road  
Wanstead  
London  
E11**

Date | February 2010

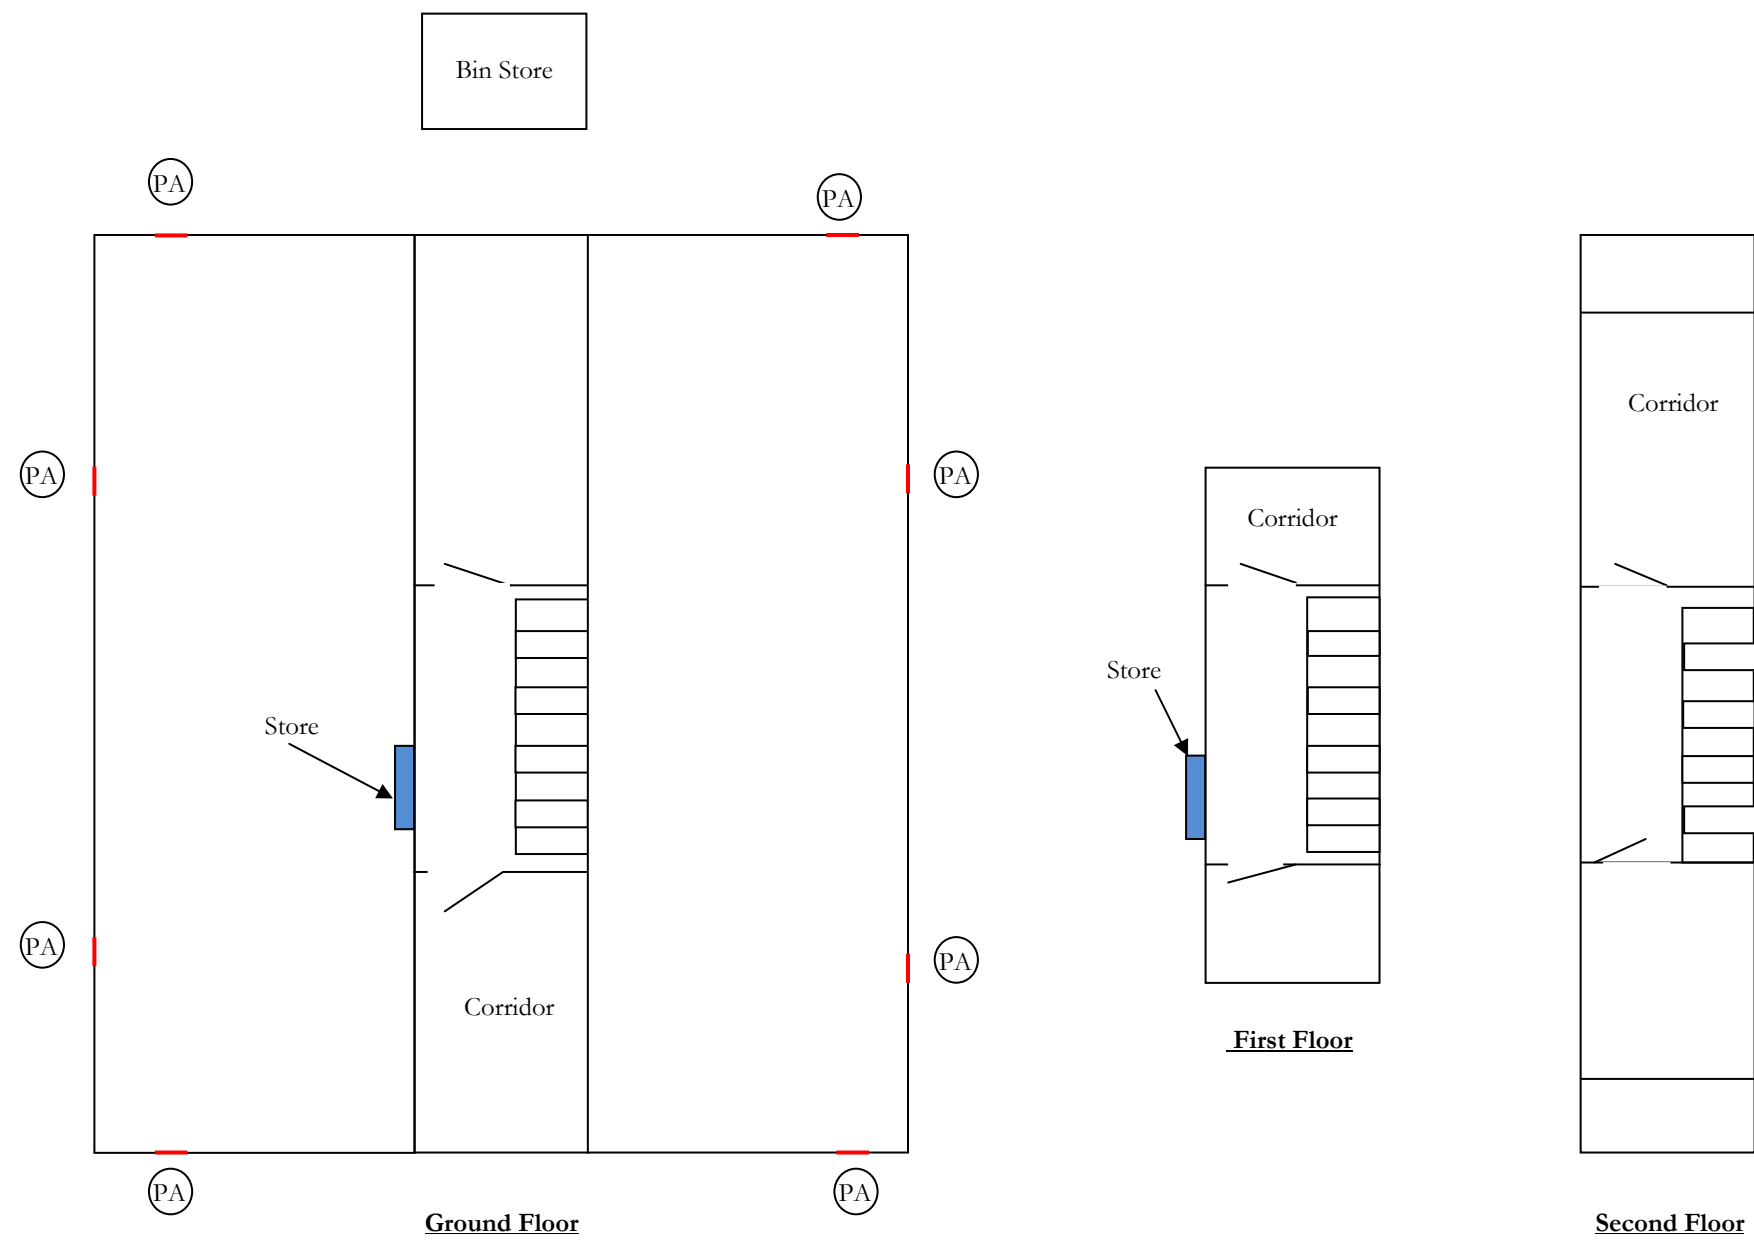
External	60900 A	AC Panel	Chrysotile	1m <sup>2</sup> each	Satisfactory condition	Sealed	4/12	Direct access	ASBESTOS PRESENT	
									Monitor condition of material.
