**Block 109-141 The Firs, Queenswood Road
TYPE 2 SURVEY REPORT S10067.5**

Site | **Block 109-141 The Firs
Queenswood Road
Wanstead
London
E11**

Date | **February 2010**

Introduction SURVEY REPORT S10067.5

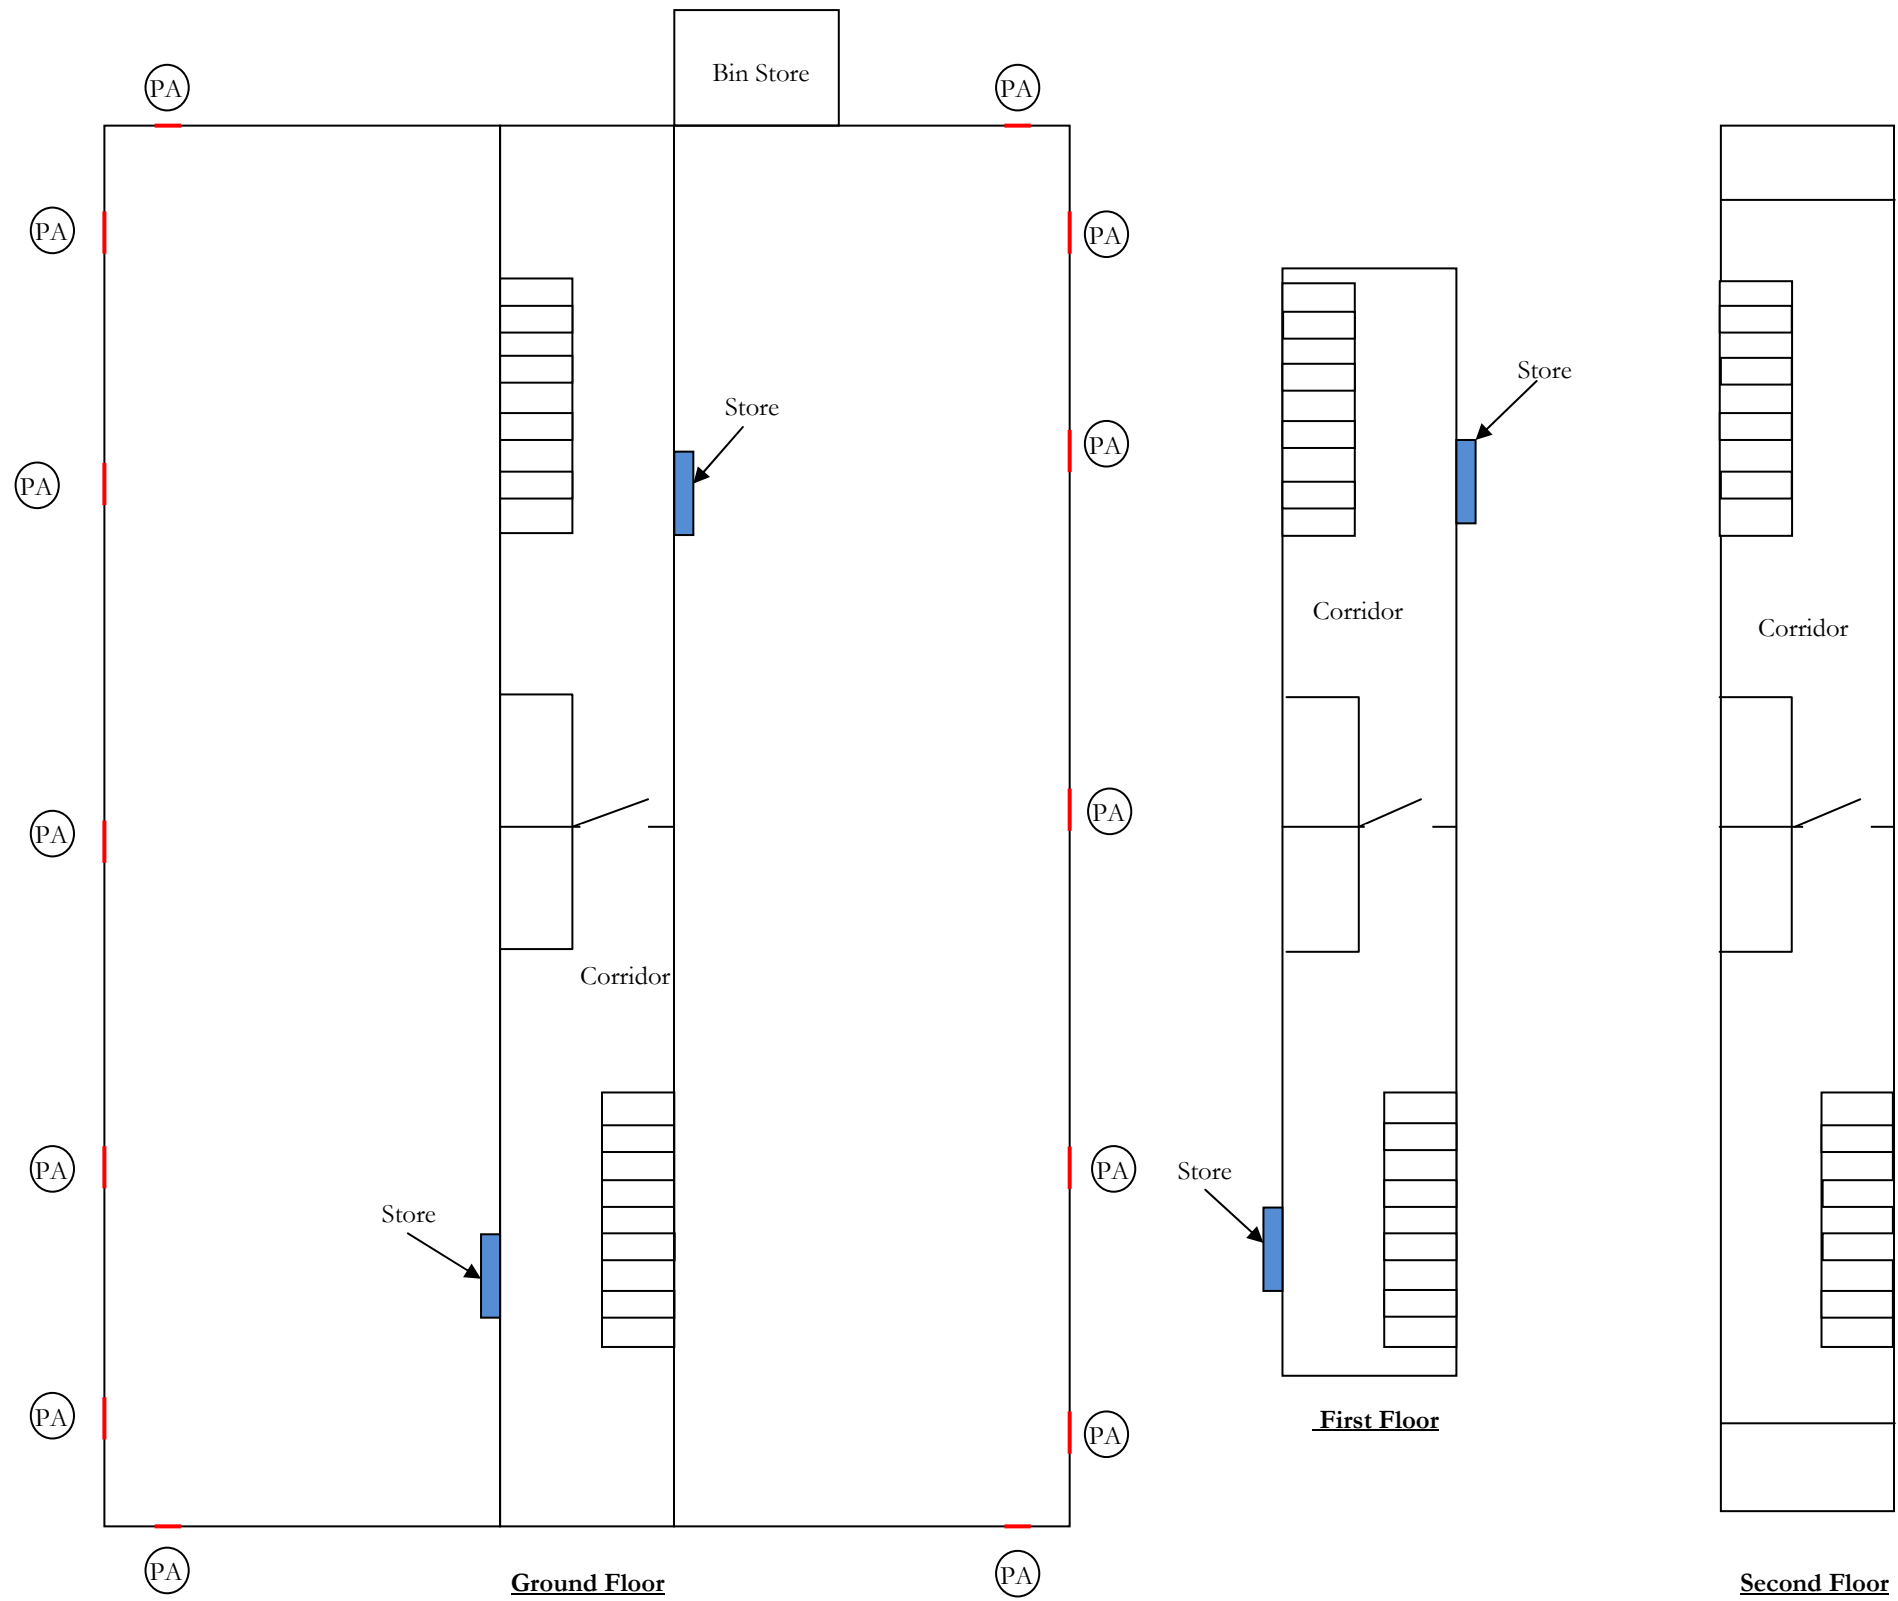
External	60898 A	AC Panel	Chrysotile	1m ²	Satisfactory condition	Sealed	4/12	Direct access	ASBESTOS PRESENT	
									Monitor condition of material.
